| | Sar | nitized Cop | y Approv | ed for Re | elease 20 |)10/07/1 | 9 : CIA-F | RDP84T | Γ00864 | 4R0001 | 0006 | 30007-1 | 0 , . | 25X1 |
|--|---|---|---|---|---|---|---|---|---|---|---|---|---|---|
| | | • | | | | HEN HOU | | | • | | | 6 1 1 1 | | |
| | 1. | THE DUAL | HEN HO | USE 3.5 | NM NW (| OF SKRU | NDA WAS | FIRST |] IDEN | TIFIED |) | | | 25 X 1 |

DUAL HEN HOUSE SKRUNDA, USSR 56-43N 21-57E

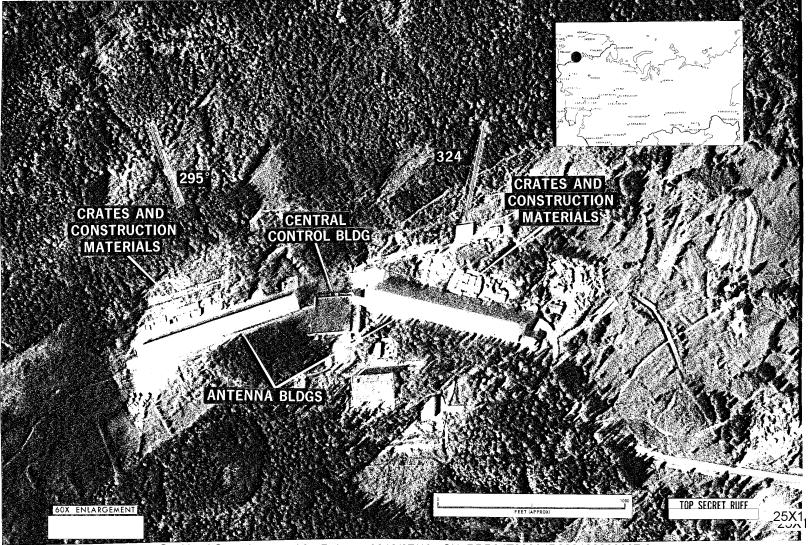
CRATES AND CONSTRUCTION MATERIALS ARE STACKED IN FRONT OF THE 2 HEN
HOUSE ANTENNA BUILDINGS. THE CENTRAL CONTROL BUILDING CONSISTS OF
A LARGE CENTRAL PORTION, 3 LOWER-LEVEL WINGS, AND 2 CONNECTING
STRUCTURES (1 EACH ON THE NE AND NW CORNERS OF THE BUILDINGS). THE
NE ANTENNA BUILDING IS ORIENTED NE/SW AND FACES ON A BORESIGHT

THE SW ANTENNA BUILDING IS ORIENTED NNE/SSW AND FACES
ON A BORESIGHT AZIMUTH 295 DEGREES. THE TERMINAL BUILDINGS FOR BOTH
ANTENNA BUILDINGS ARE PRESENT. ALL COMPONENTS OF THE OPERATIONS AREA

APPEAR TO BE EXTERNALLY COMPLETE.
